**Flood Control Project Maintenance  
Levee Inspections**  
**LMA District Cover Sheet**  
**Spring 2019 Levee Inspection Results**

**Reclamation District No. 0501 Ryer Island**

**Spring 2019 Levee Inspection Results**

**Levee Inspection Report By Mile - Spring 2019**

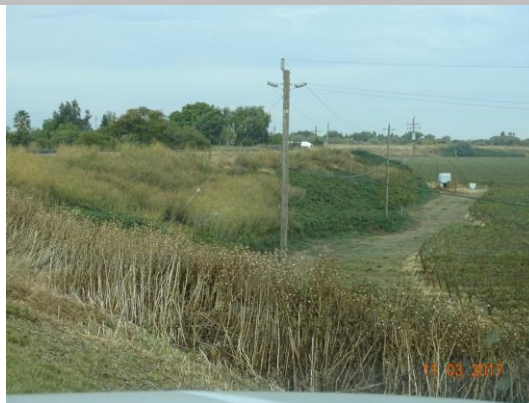
Photo 1 of 1 : SP\_2019\_RD0501\_171\_34\_20190311\_00005.jpg

LM Start	4.47	Rating **	M	Issue No.	34
LM End	4.80	Issue Type +	Ma	Location *	LS
Category	Earthen Levee			GPS Latitude/Longitude	
				Start	End
Item	Vegetation			38.277918 °	38.281507 °
				-121.637670 °	-121.641595 °
DWR ID	DWR_RD0501_03_f_2017_34				
Comment Code					
V2 : Remove the wild growth other than native grasses from the levee slopes.					
Inspector Comment					
Remove berry vines on landside slope and toe to allow inspection and access.

Photo of berry vines on landside slope and toe

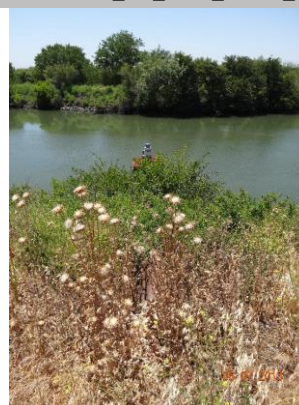
Photo 1 of 2 : UCIP\_SP\_2019\_32541\_59008.jpg

Comment Code					
Inspector Comment					
FS_ID:32541 DS_ID:21071 EP_NO: N/A Repair Type: Non-Urgent Crossing Status: Found UCIP Comments: --Contact owner--Dense vegetation limits the inspector's visibility to identify signs of pipe failure (leaks) along the waterward and landward slopes. Recommend removing vegetation along pipe alignment to conduct proper inspection of structure and appurtances. Walkway and siphon breaker not found. FIELD_STRUCT_DESC: 12-inch reinforced concrete irrigation discharge pipe through the levee, 2.5 feet below the crown. Cutoff wall around the pipe at the center of the levee. Siphon breaker at the apex of the pipe on the shoulder. Pump on a pile structure in the stream. Walkway access to pump. [Additional Reference(s): DWR Levee Log, 2005. USACE Sacramento O&M Manual 105, April 1959, (HLM 5.1)]. FS Date: 6/7/2013

View of waterward side. Pump located on pile structure in stream.

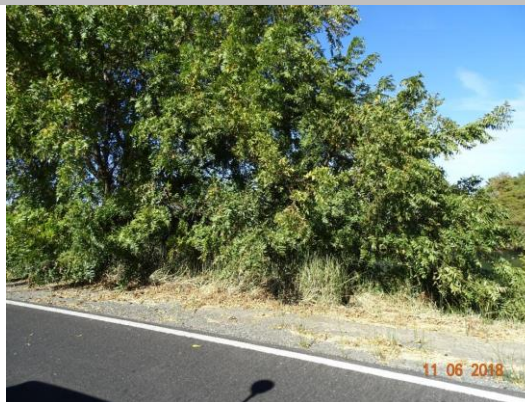
Photo 1 of 1 : SP\_2019\_RD0501\_171\_49\_20190311\_00014.jpg

LM Start	5.61	Rating **	M	Issue No.	49
LM End	5.61	Issue Type +	Ma	Location *	WS
Category	Earthen Levee			GPS Latitude/Longitude	
				Start	End
Item	Trim / Thin Trees			38.289848 °	38.289848 °
				-121.641113 °	-121.641113 °
DWR ID	DWR_RD0501_03_s_2019_49				
Comment Code					
T2 : Thin trees to allow visibility of the ground and room to flood fight.					
Inspector Comment

View of thick tree growth on the waterside slope (November 2018).

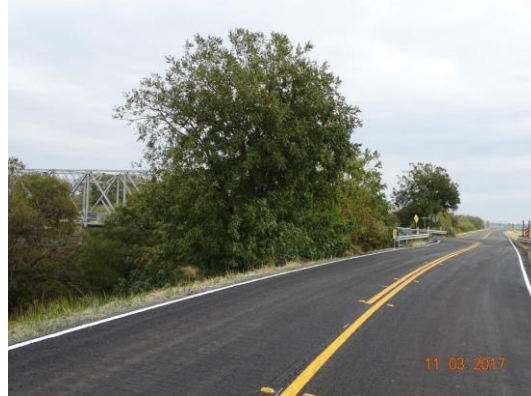
Photo 1 of 1 : SP\_2019\_RD0501\_171\_40\_20190311\_00008.jpg

LM Start	6.14	Rating **	M	Issue No.	40
LM End	6.14	Issue Type +	Ma	Location *	WS
Category	Earthen Levee			GPS Latitude/Longitude	
				Start	End
Item	Trim / Thin Trees			38.291563 °	38.291563 °
				-121.632068 °	-121.632068 °
DWR ID	DWR_RD0501_03_f_2017_40				
Comment Code					
T1 : Trim trees to at least five feet above ground level.					
Inspector Comment					
Trim/thin trees on waterside to allow inspection and access.

Photo of trees on waterside slope

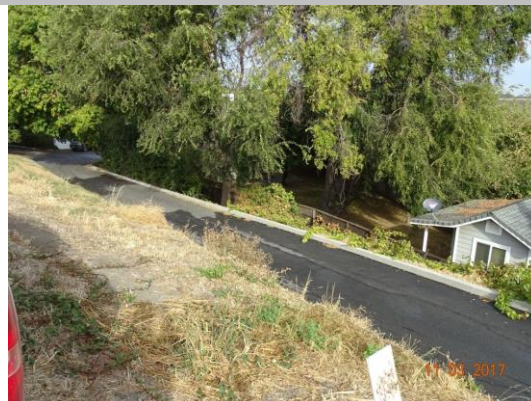
Photo 1 of 1 : SP\_2019\_RD0501\_171\_41\_20190311\_00009.jpg

LM Start	6.17	Rating **	M	Issue No.	41
LM End	6.17	Issue Type +	En	Location *	WS
Category	Earthen Levee			GPS Latitude/Longitude	
				Start	End
Item	Vegetation			38.291460 °	38.291460 °
				-121.631455 °	-121.631455 °
DWR ID	DWR_RD0501_03_f_2017_41				
Comment Code					
V6 : Landscaping					
Inspector Comment					
Trim/thin trees and landscaping to allow inspection and access to levee slope and toe.

Photo of trees and landscaping on levee slope and toe

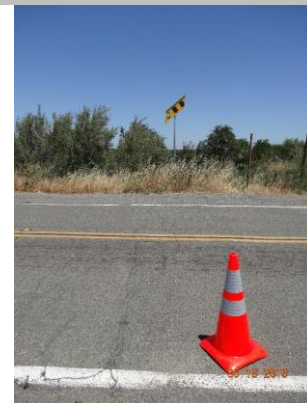
Photo 1 of 3 : UCIP\_SP\_2019\_42118\_72902.jpg

LM Start	6.40	Rating **	M	Issue No.	67
LM End	6.40	Issue Type +	En	Location *	
Category	Supplemental			GPS Latitude/Longitude	
				Start	End
Item	DWR UCIP Field Study			38.290356 °	38.290356 °
				-121.627488 °	-121.627488 °
DWR ID	24054				
Comment Code					
Inspector Comment					
FS_ID:42118 DS_ID:24054 EP_NO: N/A Repair Type: Non-Urgent Crossing Status: Indicator Found UCIP Comments: Need to determine encroachment number issued for pipe installation. FIELD_STRUCT_DESC: Natural gas pipeline of an unknown size or material through the levee at an angle, at an unknown depth. Markers visible on each side. [Additional Reference(s): DWR Levee Log, 2005. USACE Sacramento O&M Manual 105, April 1959, (HLM 6.9)]. FS Date: 6/13/2013

Markers visible on waterward side.

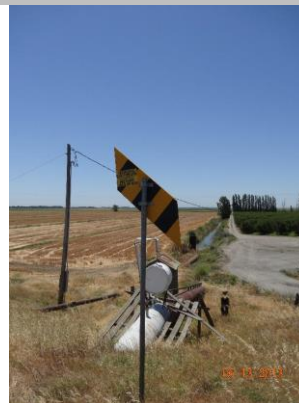
Photo 2 of 3 : UCIP\_SP\_2019\_42118\_72901.jpg

LM Start	6.40	Rating **	M	Issue No.	67 (cont)	
LM End	6.40	Issue Type +	En	Location *		
Category	Supplemental			GPS Latitude/Longitude		
				Start	End	
Item	DWR UCIP Field Study			38.290356 °	38.290356 °	
				-121.627488 °	-121.627488 °	
DWR ID	24054					
Comment Code						
Inspector Comment						
FS_ID:42118						
DS_ID:24054						
EP_NO: N/A						
Repair Type: Non-Urgent						
Crossing Status: Indicator Found						
UCIP Comments: Need to determine encroachment number issued for pipe installation.						
FIELD_STRUCT_DESC: Natural gas pipeline of an unknown size or material through the levee at an angle, at an unknown depth. Markers visible on each side. [Additional Reference(s): DWR Levee Log, 2005. USACE Sacramento O&M Manual 105, April 1959, (HLM 6.9)].						
FS Date: 6/13/2013

Marker visible on landward side.

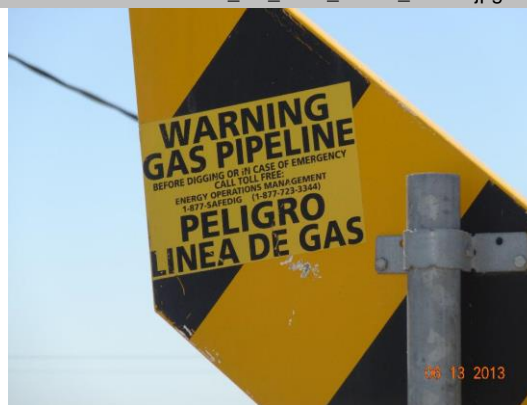
Photo 3 of 3 : UCIP\_SP\_2019\_42118\_72900.jpg

Marker with contact information on landward side.

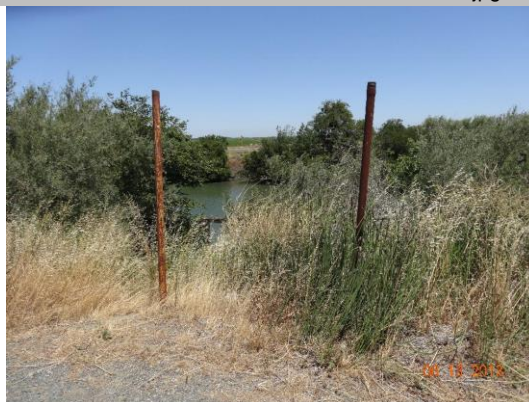
Photo 2 of 3 : UCIP\_SP\_2019\_19668\_33443.jpg

View of waterward side. Metal posts near the levee crown.

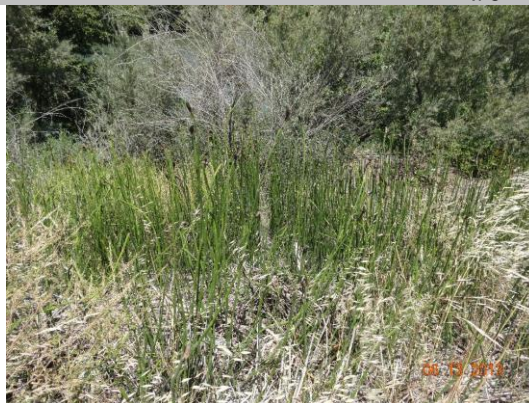
Photo 3 of 3 : UCIP\_SP\_2019\_32543\_59026.jpg

Comment Code						
Inspector Comment						
FS_ID:32543 DS_ID:21058 EP_NO: N/A Repair Type: Non-Urgent Crossing Status: Found UCIP Comments: Dense vegetation limits the inspector's visibility to identify signs of pipe failure (leaks) along the waterward slope. Recommend removing vegetation along pipe alignment to conduct proper inspection of structure and appurtenances. Need to find pipe owner. Unable to determine status of crossing. FIELD_STRUCT_DESC: *ABANDONED* 8-inch coated steel irrigation discharge pipe through the levee, 2.7 feet below the crown. Siphon breaker at the apex of the pipe on the landside (LS) shoulder. Surge chamber at the LS toe. Pump near the waterside (WS) toe. Pipe exposed on the LS. 4-foot by 3-foot concrete platform on the LS toe. 3-inch electrical conduit of an unknown material runs along the 8-inch coated steel pipe. [Additional Reference(s): DWR Levee Log, 2005. USACE Sacramento O&M Manual 105, April 1959, (HLM 6.9)]. FS Date: 6/13/2013

View of waterward side. Dense vegetation along levee slope.

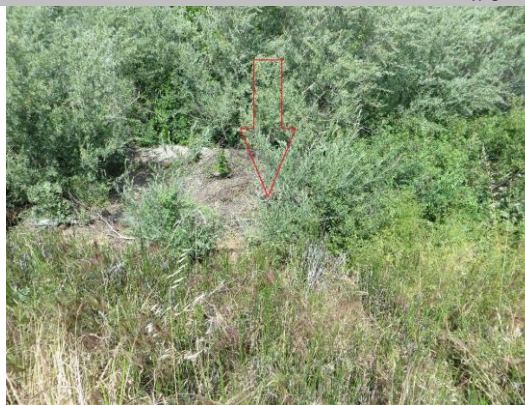
Photo 2 of 2 : UCIP\_SP\_2019\_44748\_73947.jpg

Pipe visible on upstream side of wooden platform on the WS slope.

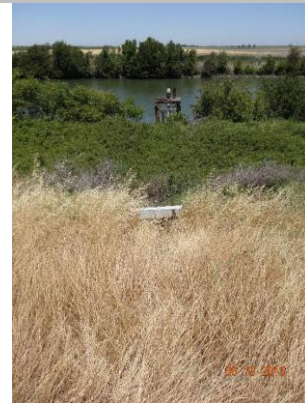
Photo 1 of 3 : UCIP\_SP\_2019\_32544\_59034.jpg

Comment Code						
Inspector Comment						
FS_ID:32544						
DS_ID:21060						
EP_NO: N/A						
Repair Type: Non-Urgent						
Crossing Status: Found						
UCIP Comments: Dense vegetation limits the inspector's visibility to identify signs of pipe failure (leaks) along the slope. Recommend removing vegetation along pipe alignment to conduct proper inspection of structure and appurtenances. Walkway missing but platform remain on the waterward side.						
FIELD_STRUCT_DESC: 12-inch irrigation discharge pipe of an unknown material through the levee, 6.5 feet below the crown. Switch panel on the waterside (WS) slope. Pump on a pile structure in the stream. [Additional Reference(s): DWR Levee Log, 2005. USACE Sacramento O&M Manual 105, April 1959, (HLM 7.3)].						
FS Date: 6/13/2013

View of waterward side. Support piles, conduit line, and pump visible on waterward side. Dense vegetation covers waterward slope.

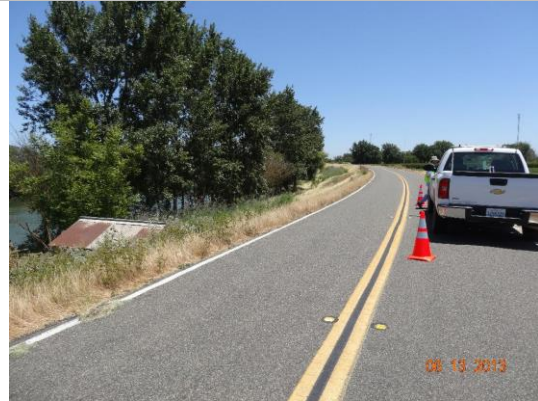
Photo 1 of 3 : UCIP\_SP\_2019\_46834\_33471.jpg

Comment Code						
Inspector Comment						
FS_ID:46834 DS_ID:21061 EP_NO: N/A Repair Type: Non-Urgent Crossing Status: Found UCIP Comments: 11/19/2015 DWR Inspector (H. Phillips) coordinated with LMA superintendent and the owner for this crossing is Walter Koeing, APN No. 042220040. According to LMA superintendent owner installed filter system with fence on landward side and fence around pump in 2012. Pipe not replaced in 2012, this pipe would be a good candidate for internal inspection since the installation date for this crossing was recorded as 1946.06/13/2013 Conduit visible on landward side; new gate on WS toe; filtration system with security fence; Pipe has been upgraded--need permit authorizing work and owner. Dense vegetation limits the inspector's visibility to identify signs of pipe failure (leaks) along the waterward slope. Recommend removing vegetation along pipe alignment to conduct proper inspection of structure and appurtenances. FIELD_STRUCT_DESC: 8-inch steel irrigation discharge pipe through the levee, 3.7 feet below the crown. Siphon breaker and service pole on the landside (LS) slope. 2-inch electrical conduit of an unknown material runs parallel to the 8-inch steel pipe. Pump in a pump house on the waterside (WS) slope. [Additional Reference(s): DWR Levee Log, 2005. USACE Sacramento O&M Manual 105, April 1959, (HLM 8.0)]. FS Date: 6/13/2013

Overview of levee crown.

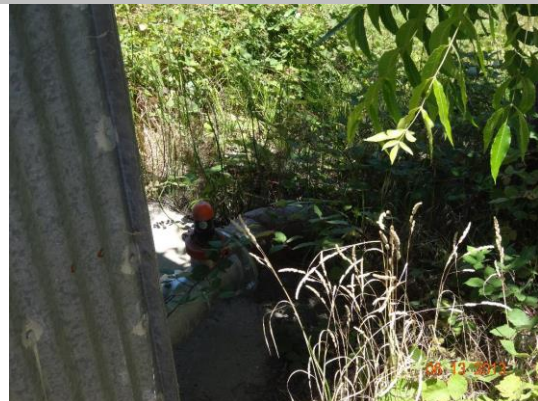
Photo 2 of 3 : UCIP\_SP\_2019\_46834\_33468.jpg

Pipe connection after pump station.

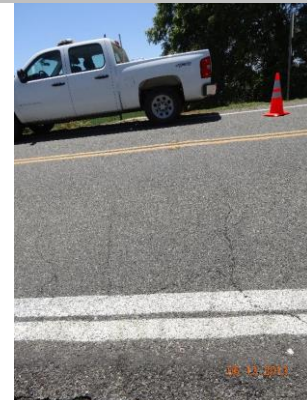
Photo 1 of 3 : UCIP\_SP\_2019\_50025\_59039.jpg

Comment Code					
Inspector Comment					
FS_ID:50025 DS_ID:21063 EP_NO: 11812 Repair Type: Non-Urgent Crossing Status: Found UCIP Comments: 8/22/2016 Crossing has been downgraded from Urgent to Non-Urgent no levee damage appears to be present along pipe alignment. There appears to be an erosion site adjacent to this crossing. Need to coordinate with DWR Inspectors. (DWR UCIP - omagana)6/07/2013 Open cut section of levee on LS slope 8 foot wide--repair work needed. Abandoned pump on waterward berm. Dense vegetation--Recommend removing vegetation along pipe alignment to conduct proper inspection of structure and appurtenances on waterward side. (DWR UCIP - omagana) FIELD_STRUCT_DESC: 14-inch coated steel irrigation discharge pipe and a 1.25-inch electrical conduit of an unknown material through the levee, both 3 feet below the crown. Cutoff wall around the pipe and conduit at the center of the levee. Siphon breaker at the apex of the pipe on the landside (LS) shoulder. Slant pump on the waterside (WS) slope. Discharge structure at the LS toe. Rock revetment on the WS slope. (Plans to replace a 14-inch irrigation pipe through the levee crown and a slant pump on the riverbank authorized under Permit No. 11812, 1976 - Harry H. Rasmussen). [Additional Reference(s): DWR Levee Log, 2005]. FS Date: 8/22/2016

View of levee crown at crossing.

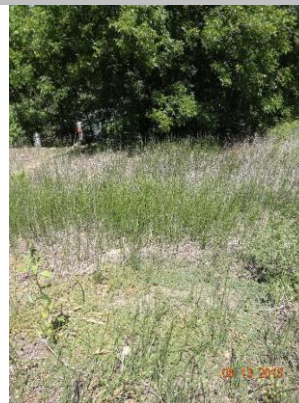
Photo 2 of 3 : UCIP\_SP\_2019\_50025\_59042.jpg

Comment Code						
Inspector Comment						
FS_ID:50025 DS_ID:21063 EP_NO: 11812 Repair Type: Non-Urgent Crossing Status: Found UCIP Comments: 8/22/2016 Crossing has been downgraded from Urgent to Non-Urgent no levee damage appears to be present along pipe alignment. There appears to be an erosion site adjacent to this crossing. Need to coordinate with DWR Inspectors. (DWR UCIP - omagana)6/07/2013 Open cut section of levee on LS slope 8 foot wide--repair work needed. Abandoned pump on waterward berm. Dense vegetation--Recommend removing vegetation along pipe alignment to conduct proper inspection of structure and appurtenances on waterward side. (DWR UCIP - omagana) FIELD_STRUCT_DESC: 14-inch coated steel irrigation discharge pipe and a 1.25-inch electrical conduit of an unknown material through the levee, both 3 feet below the crown. Cutoff wall around the pipe and conduit at the center of the levee. Siphon breaker at the apex of the pipe on the landside (LS) shoulder. Slant pump on the waterside (WS) slope. Discharge structure at the LS toe. Rock revetment on the WS slope. (Plans to replace a 14-inch irrigation pipe through the levee crown and a slant pump on the riverbank authorized under Permit No. 11812, 1976 - Harry H. Rasmussen). [Additional Reference(s): DWR Levee Log, 2005]. FS Date: 8/22/2016

View of WS--pump located at the berm edge.

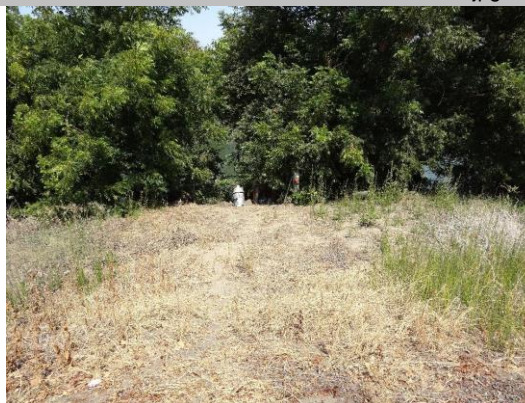
Photo 3 of 3 : UCIP\_SP\_2019\_50025\_75668.jpg

View of WS.

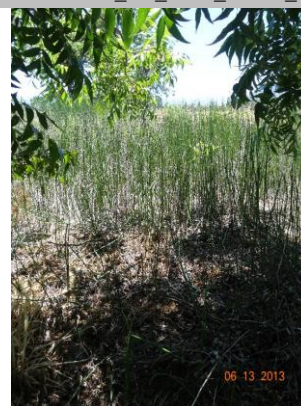
Photo 3 of 3 : UCIP\_SP\_2019\_32546\_59049.jpg

Comment Code						
Inspector Comment						
FS_ID:32546						
DS_ID:21064						
EP_NO: N/A						
Repair Type: Non-Urgent						
Crossing Status: Found						
UCIP Comments: Debris (pipe section) located on waterward berm.						
Dense vegetation limits the inspector's visibility to identify signs of pipe						
failure (leaks) along the waterward slope. Recommend removing						
vegetation along pipe alignment to conduct proper inspection of						
structure and appurtenances.						
FIELD_STRUCT_DESC: 8-inch steel irrigation discharge pipe through						
the levee, 2.7 feet below the crown. Pump in a pump house at the						
landside (LS) toe. [Additional Reference(s): DWR Levee Log, 2005.						
USACE Sacramento O&M Manual 105, April 1959, (HLM 8.2)].						
FS Date: 6/13/2013

View of waterward side looking up at levee shoulder.

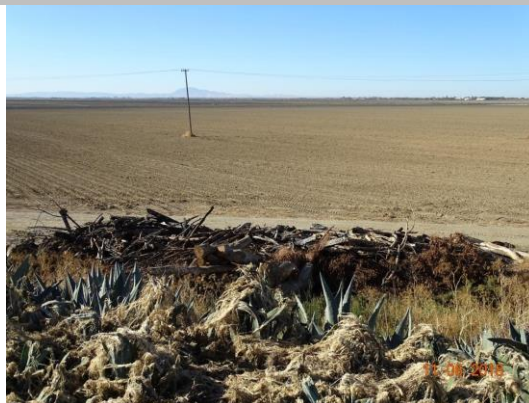
Photo 1 of 1 : SP\_2019\_RD0501\_172\_15\_20190311\_00003.jpg

LM Start	0.11	Rating **	M	Issue No.	15
LM End	0.11	Issue Type +	En	Location *	LS
Category	Earthen Levee			GPS Latitude/Longitude	
				Start	End
Item	Encroachments			38.284177 °	38.284177 °
				-121.604760 °	-121.604760 °
DWR ID	DWR_RD0501_04_f_2018_15				
Comment Code					
PR : Prunings					
Inspector Comment					
Pruning pile at landside toe needs removal.

View of pruning pile on the landside toe (November 2018)

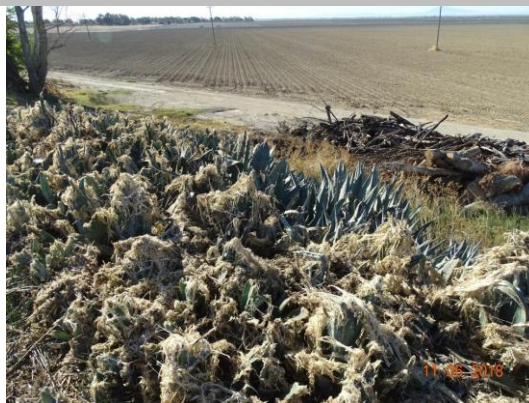
Photo 1 of 1 : SP\_2019\_RD0501\_172\_16\_20190311\_00004.jpg

LM Start	0.11	Rating **	M	Issue No.	16
LM End	0.11	Issue Type +	En	Location *	LS
Category	Earthen Levee			GPS Latitude/Longitude	
				Start	End
Item	Vegetation			38.284177 °	38.284177 °
				-121.604760 °	-121.604760 °
DWR ID	DWR_RD0501_04_f_2018_16				
Comment Code					
V6 : Landscaping					
Inspector Comment					
Patch of cactus is being dealt with by LMA

View of cactus on the land side slope. LMA has chopped and sprayed cactus at the top of the slope and is in process of dealing with cactus along the entire slope (November 2018).

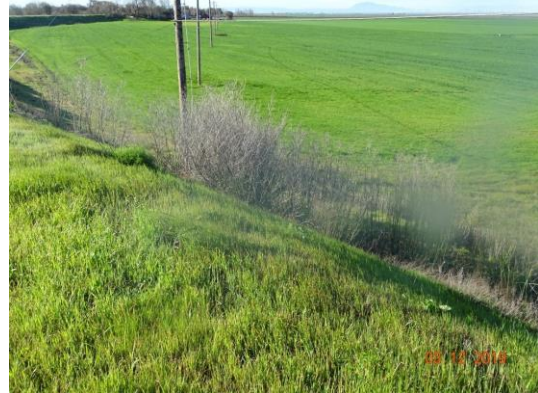
Photo 1 of 1 : SP\_2019\_RD0501\_172\_22\_20190314\_00034.jpg

LM Start	0.43	Rating **	M	Issue No.	22
LM End	0.43	Issue Type +	Ma	Location *	LS
Category	Earthen Levee			GPS Latitude/Longitude	
				Start	End
Item	Vegetation			38.280360 °	38.280360 °
				-121.601530 °	-121.601530 °
DWR ID	DWR_RD0501_04_s_2019_22				
Comment Code					
V1 : Control annual grass and weeds on the levee slopes and easements.					
Inspector Comment					
Remove vegetation from landside slope.

View looking downstream at vegetation on the land side slope (Spring 2019).

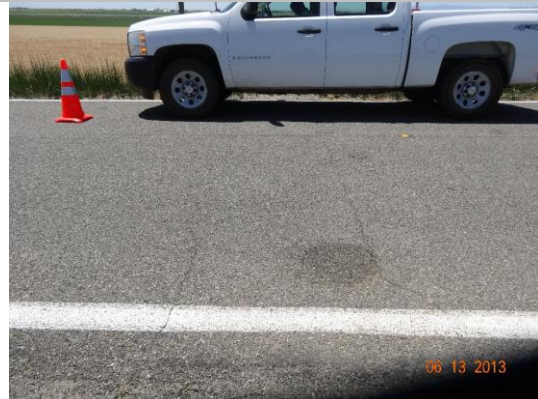
Photo 1 of 3 : UCIP\_SP\_2019\_32547\_59050.jpg

Comment Code					
Inspector Comment					
FS_ID:32547 DS_ID:21080 EP_NO: 18135 Repair Type: Non-Urgent Crossing Status: Found UCIP Comments: Cracks visible on levee crown could be associated with pipe vibration or settlement. Burrow activity on landward side. Recommend removing vegetation along pipe alignment on landward side to conduct proper inspection of structure and appurtenances. FIELD_STRUCT_DESC: 10-inch galvanized iron irrigation discharge pipe through the levee, 3.5 feet below the crown. Cutoff wall around the pipe on the landside (LS) shoulder. Slant pump and pump house on the waterside (WS) slope. Concrete standpipe and power pole at the LS toe. Service pole on the LS slope. Pipe exposed on both slopes. Two crossings are nearby: A 10-inch pipe and an 8-inch pipe crossings are approximately 5 feet apart. (Plans to replace an existing pump and pipeline with a new pump and pipeline authorized under Permit No. 2446, 1957 - Doris R. Geary. Plans to replace an existing water pipe with a 10-inch steel pipe through the levee authorized under Permit No. 18135, 2006 - Charlotte Gilmore). [Additional Reference(s): DWR Levee Log, 2005]. FS Date: 6/7/2013

View of levee crown.

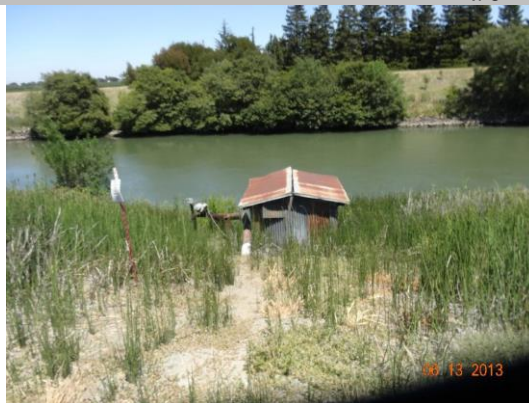
Photo 2 of 3 : UCIP\_SP\_2019\_32547\_59051.jpg

Comment Code						
Inspector Comment						
FS_ID:32547 DS_ID:21080 EP_NO: 18135 Repair Type: Non-Urgent Crossing Status: Found UCIP Comments: Cracks visible on levee crown could be associated with pipe vibration or settlement. Burrow activity on landward side. Recommend removing vegetation along pipe alignment on landward side to conduct proper inspection of structure and appurtenances. FIELD_STRUCT_DESC: 10-inch galvanized iron irrigation discharge pipe through the levee, 3.5 feet below the crown. Cutoff wall around the pipe on the landside (LS) shoulder. Slant pump and pump house on the waterside (WS) slope. Concrete standpipe and power pole at the LS toe. Service pole on the LS slope. Pipe exposed on both slopes. Two crossings are nearby: A 10-inch pipe and an 8-inch pipe crossings are approximately 5 feet apart. (Plans to replace an existing pump and pipeline with a new pump and pipeline authorized under Permit No. 2446, 1957 - Doris R. Geary. Plans to replace an existing water pipe with a 10-inch steel pipe through the levee authorized under Permit No. 18135, 2006 - Charlotte Gilmore). [Additional Reference(s): DWR Levee Log, 2005]. FS Date: 6/7/2013

Overview of waterward side--2 crossings located within 5 feet.

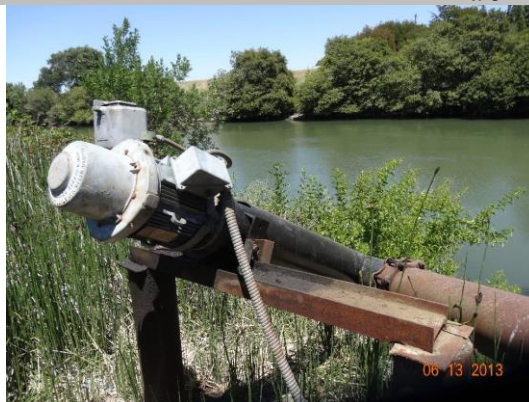
Photo 3 of 3 : UCIP\_SP\_2019\_32547\_59053.jpg

Slant pump located on waterward side. 10 inch pipe connects at an angle to tar coated pipe.

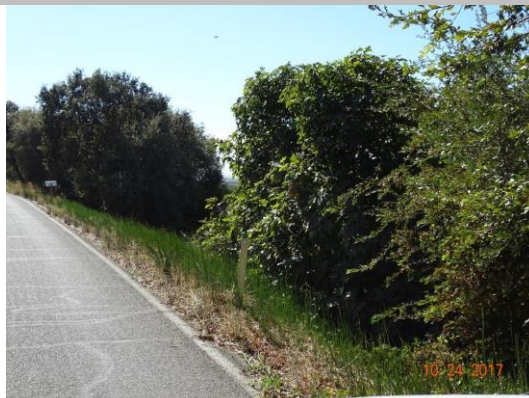
Photo 1 of 1 : SP\_2019\_RD0501\_172\_12\_20190311\_00002.jpg

LM Start	0.99	Rating **	M	Issue No.	12
LM End	0.99	Issue Type +	En	Location *	LS
Category	Earthen Levee			GPS Latitude/Longitude	
				Start	End
Item	Vegetation			38.272650 °	38.272650 °
				-121.603960 °	-121.603960 °
DWR ID	DWR_RD0501_04_f_2017_12				
Comment Code					
V6 : Landscaping					
Inspector Comment					
Trim fig and other trees to allow inspection and access to landside slope and toe.

View of fig and other trees on landside slope and toe

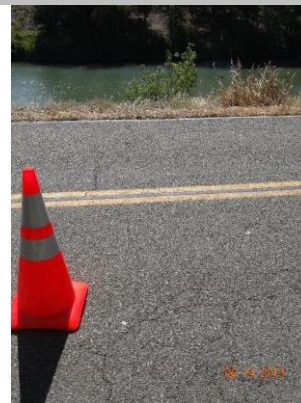
Photo 1 of 3 : UCIP\_SP\_2019\_32550\_59068.jpg

LM Start	1.08	Rating **	M	Issue No.	26
LM End	1.08	Issue Type +	En	Location *	
Category	Supplemental			GPS Latitude/Longitude	
				Start	End
Item	DWR UCIP Field Study			38.271400 °	38.271400 °
				-121.604368 °	-121.604368 °
DWR ID	21073				
Comment Code					
Inspector Comment					
FS_ID:32550 DS_ID:21073 EP_NO: N/A Repair Type: Non-Urgent Crossing Status: Indicator Found UCIP Comments: Unable to determine if the pipe goes through the levee, need As-Built drawings; Need owner information. FIELD_STRUCT_DESC: 1.5-inch communications conduit of an unknown material through the levee, 2 feet below the crown. Pole and anchor on the landside (LS) slope. [Additional Reference(s): DWR Levee Log, 2005]. FS Date: 6/13/2013

Levee crown at crossing.

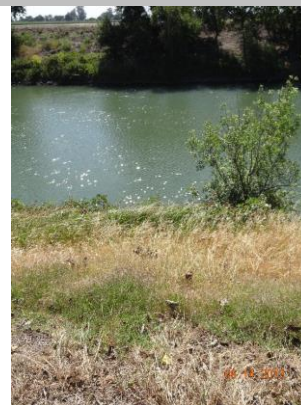
Photo 2 of 3 : UCIP\_SP\_2019\_32550\_59067.jpg

View of waterward side.

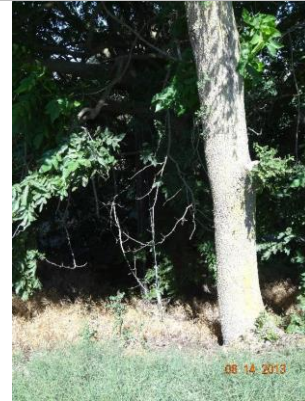
Photo 3 of 3 : UCIP\_SP\_2019\_32550\_59069.jpg

LM Start	1.08	Rating **	M	Issue No.	26 (cont)	
LM End	1.08	Issue Type +	En	Location *		
Category	Supplemental			GPS Latitude/Longitude		
				Start	End	
Item	DWR UCIP Field Study			38.271400 °	38.271400 °	
				-121.604368 °	-121.604368 °	
DWR ID	21073					
Comment Code						
Inspector Comment						
FS_ID:32550						
DS_ID:21073						
EP_NO: N/A						
Repair Type: Non-Urgent						
Crossing Status: Indicator Found						
UCIP Comments: Unable to determine if the pipe goes through the levee. need As-Built drawings; Need owner information.						
FIELD_STRUCT_DESC: 1.5-inch communications conduit of an unknown material through the levee, 2 feet below the crown. Pole and anchor on the landside (LS) slope. [Additional Reference(s): DWR Levee Log, 2005].						
FS Date: 6/13/2013

View of landward side--power pole and guy wire under trees.

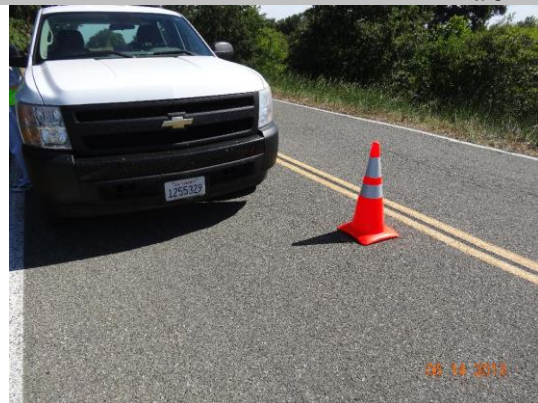
Photo 1 of 3 : UCIP\_SP\_2019\_32551\_59070.jpg

Comment Code						
Inspector Comment						
FS_ID:32551						
DS_ID:21074						
EP_NO: N/A						
Repair Type: Non-Urgent						
Crossing Status: Found						
UCIP Comments: Unable to determine status of crossing. Pipe visible on waterward side--could be the pipe that was supposed to be removed under permit number 13983 (1985). Also present is a 1.5 inch conduit along the 8 inch pipe. Need to coordinate with owner.						
FIELD_STRUCT_DESC: 8-inch steel irrigation discharge pipe through the levee, 6.4 feet below the crown. Pump on a pile structure in the stream. Service pole on the landside (LS) slope. (8-inch pipe should have been removed and replaced with a 12-inch pipe authorized under Permit No. 13983, 1984 - Mrs. John Thomas). [Additional Reference(s): DWR Levee Log, 2005. USACE Sacramento O&M Manual 105, April 1959, (HLM 1.3)].						
FS Date: 6/13/2013

View of levee crown at crossing.

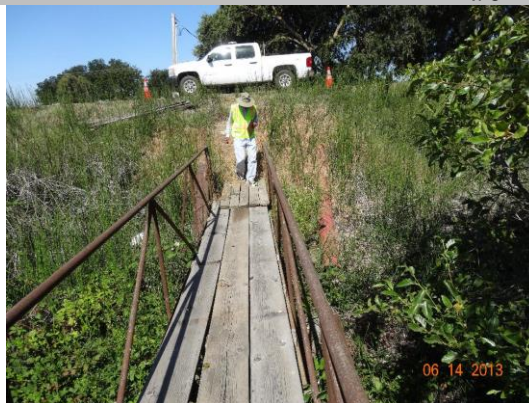
Photo 2 of 3 : UCIP\_SP\_2019\_32551\_59072.jpg

Comment Code						
Inspector Comment						
FS_ID:32551 DS_ID:21074 EP_NO: N/A Repair Type: Non-Urgent Crossing Status: Found UCIP Comments: Unable to determine status of crossing. Pipe visible on waterward side--could be the pipe that was supposed to be removed under permit number 13983 (1985). Also present is a 1.5 inch conduit along the 8 inch pipe. Need to coordinate with owner. FIELD_STRUCT_DESC: 8-inch steel irrigation discharge pipe through the levee, 6.4 feet below the crown. Pump on a pile structure in the stream. Service pole on the landside (LS) slope. (8-inch pipe should have been removed and replaced with a 12-inch pipe authorized under Permit No. 13983, 1984 - Mrs. John Thomas). [Additional Reference(s): DWR Levee Log, 2005. USACE Sacramento O&M Manual 105, April 1959, (HLM 1.3)]. FS Date: 6/13/2013

Abandoned pipe to the right of walkway.

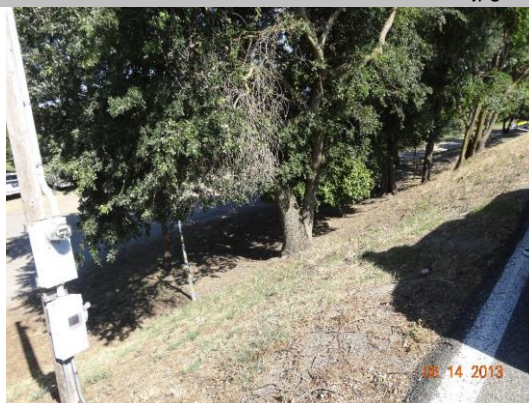
Photo 3 of 3 : UCIP\_SP\_2019\_32551\_59071.jpg

View of landward side--power pole on slope.

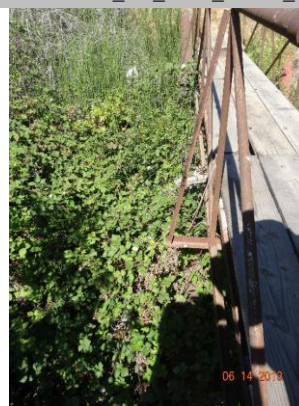
Photo 3 of 3 : UCIP\_SP\_2019\_32552\_59075.jpg

Comment Code						
Inspector Comment						
FS_ID:32552 DS_ID:21095 EP_NO: 13983 Repair Type: Non-Urgent Crossing Status: Found UCIP Comments: Abandoned pipe was to be removed during the installation of new 12-inch pipe crossing. Need to contact pipe owner. Unable to confirm crossing--need additional records for crossing. FIELD_STRUCT_DESC: 12-inch coated steel irrigation discharge pipe through the levee, 5 feet below the crown. Cutoff wall around the pipe at the center of the levee. Siphon breaker at the apex of the pipe on the landside (LS) shoulder. Pump on a pile structure in the stream. Service pole on the LS slope. Pipe connects to a 10-inch steel pipe along the LS slope at the shoulder and similarly to a preexisting 8-inch pipe on the waterside (WS). (8-inch pipe should have been removed and replaced with a 12-inch pipe authorized under Permit No. 13983, 1984 - Mrs. John Thomas). FS Date: 6/13/2013

Pipe suspended on waterward side along walkway.

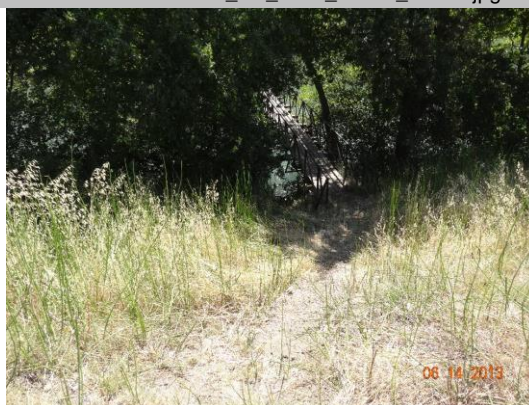
Photo 2 of 3 : UCIP\_SP\_2019\_32553\_59081.jpg

View of waterward side.

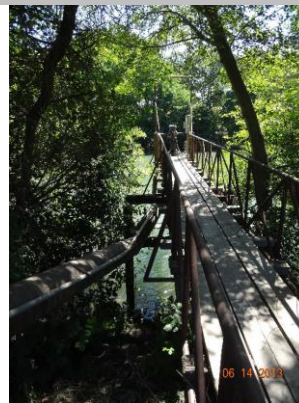
Photo 3 of 3 : UCIP\_SP\_2019\_32553\_59080.jpg

Comment Code						
Inspector Comment						
FS_ID:32553 DS_ID:21077 EP_NO: N/A Repair Type: Non-Urgent Crossing Status: Found UCIP Comments: Dense vegetation limits the inspector's visibility to identify signs of pipe failure (leaks) along the waterward and landward slope. Recommend removing vegetation along pipe alignment to conduct proper inspection of structure and appurtenances. FIELD_STRUCT_DESC: 14-inch steel irrigation discharge pipe through the levee, 8 feet below the crown. 2-inch electrical conduit of an unknown material through the levee, at an unknown depth. Siphon breaker on the landside (LS) slope. Pump on a pile structure in the stream. [Additional Reference(s): DWR Levee Log, 2005. USACE Sacramento O&M Manual 105, April 1959, (HLM 2.0)]. FS Date: 6/13/2013

Waterward side--catwalk, conduit line, pump, and support piles.

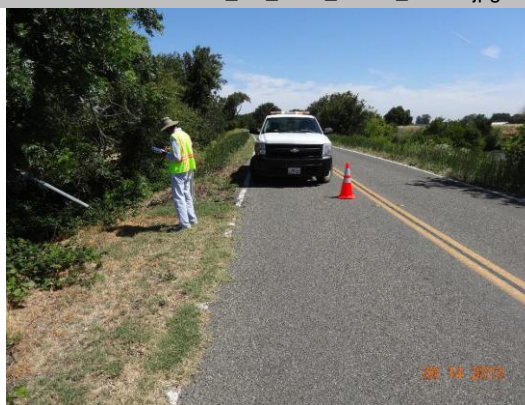
Photo 1 of 3 : UCIP\_SP\_2019\_32863\_59483.jpg

Comment Code						
Inspector Comment						
FS_ID:32863 DS_ID:21078 EP_NO: N/A Repair Type: Non-Urgent Crossing Status: Found UCIP Comments: Broken concrete box on landward slope. Disturbed soil on waterward slope--unable to determine section disturbed. Dense vegetation limits the inspector's visibility to identify signs of pipe failure (leaks) along the waterwar slope. Recommend removing vegetation along pipe alignment to conduct proper inspection of structure and appurtenances. FIELD_STRUCT_DESC: *ABANDONED* 6-inch and working 6-inch steel irrigation discharge pipes through the levee, 2.5 feet and 5 feet below the crown, respectively. Pipes are within 5 feet of each other. 1.5-inch electrical conduit of an unknown material through the levee, at an unknown depth. Pump in a pump house on the waterside (WS) slope. [Additional Reference(s): DWR Levee Log, 2005. USACE Sacramento O&M Manual 105, April 1959, (HLM 2.3)]. FS Date: 6/13/2013

View of levee crown at crossing.

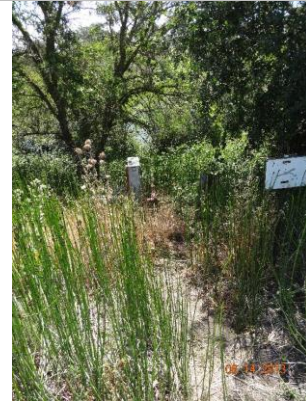
View of waterward side with dense vegetation along slope.

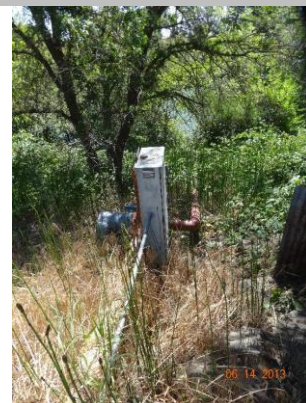
View of waterward side--conduit, pump, control panel, and pipe. Soil piled on right corner of photo--excavation?
